# **Assessment of Dam Safety of Coal Combustion Surface Impoundments**

**Indianapolis Power & Light Company**

**Petersburg Generating Station**

**November 15, 2010**

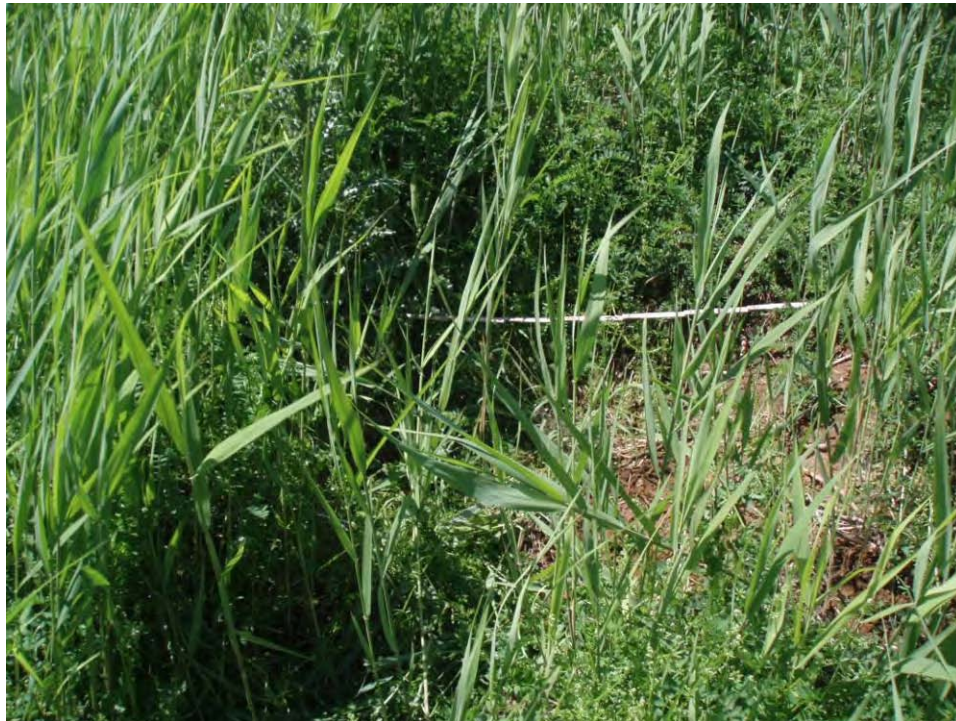
60. Pond B - South embankment exterior slope, looking north at 4'Wx1'D erosion feature.

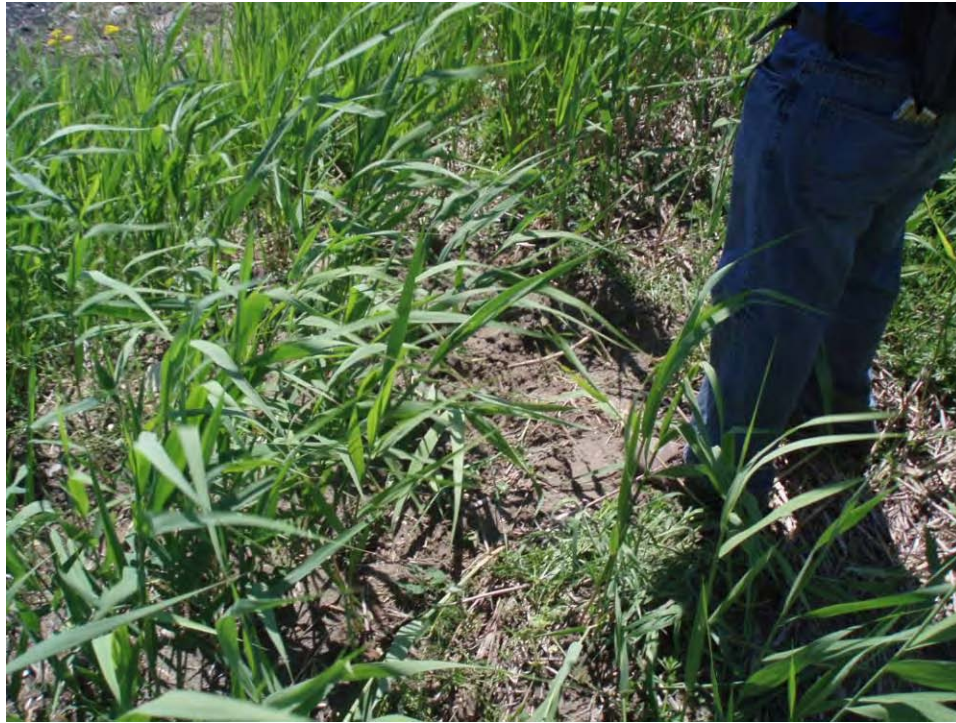
61. Pond B – South embankment exterior slope looking at bare spots of very soft, fine grained stabilized FGD.

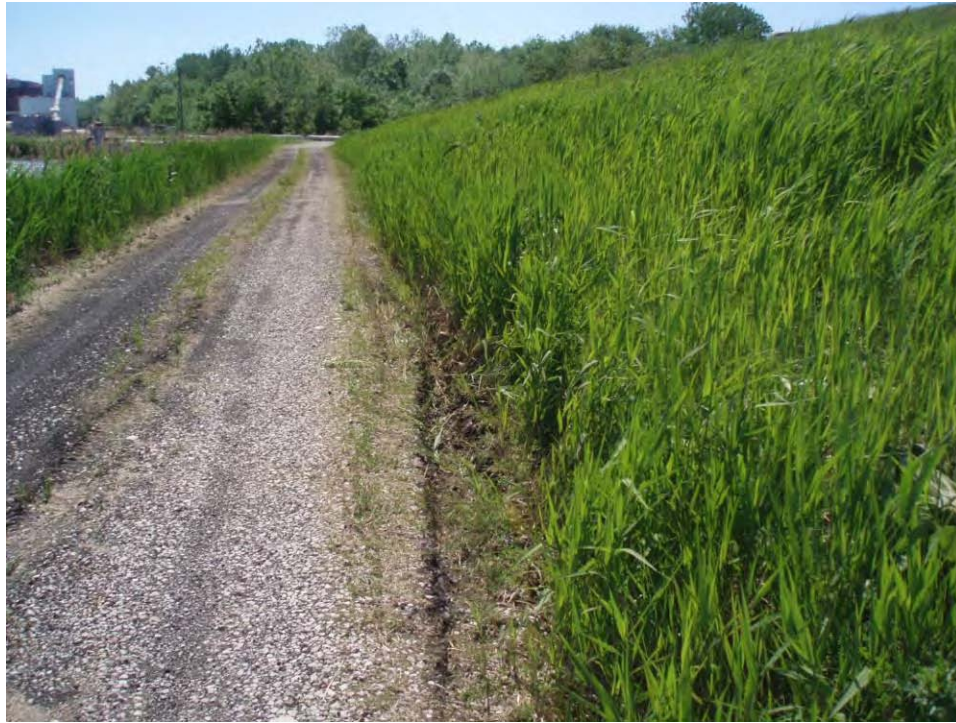
63. Pond B – South embankment exterior slope, looking southwest at possible seepage at toe.

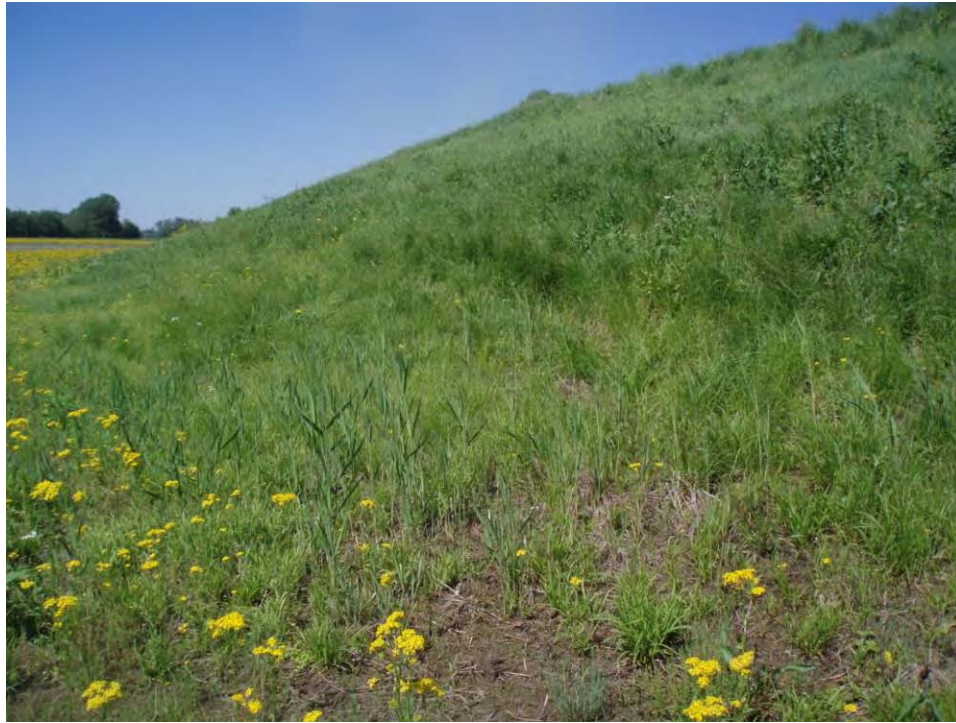
73. Pond B – West embankment lower exterior slope, looking north at saturated area at toe of slope.

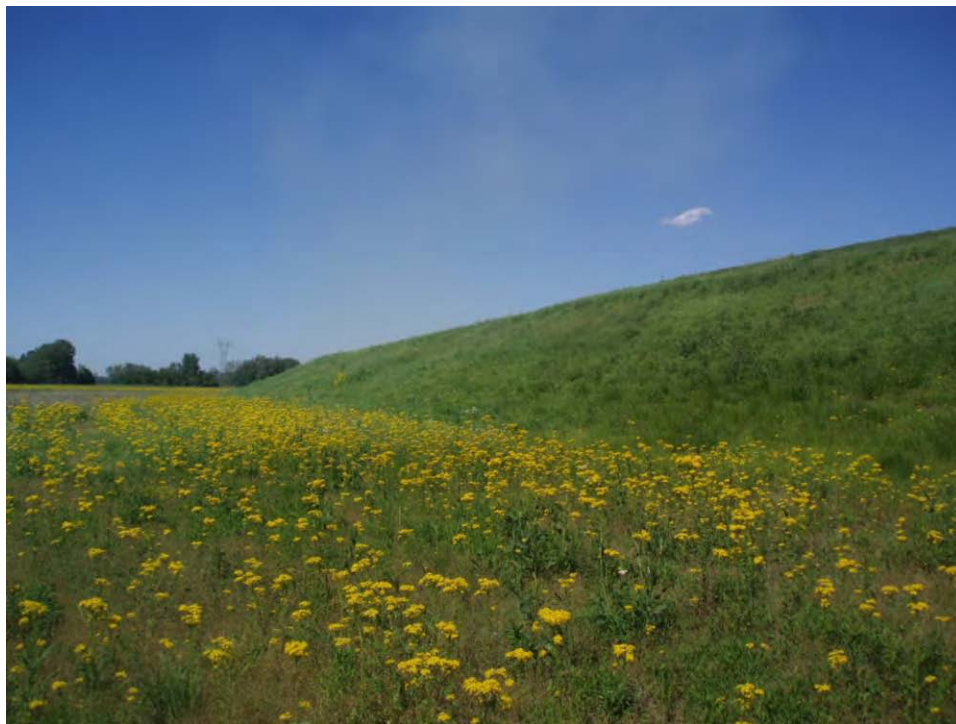
74. Pond B – West embankment, looking north at downstream area in flood plain. Note field area is saturated and wet from recent storm events.

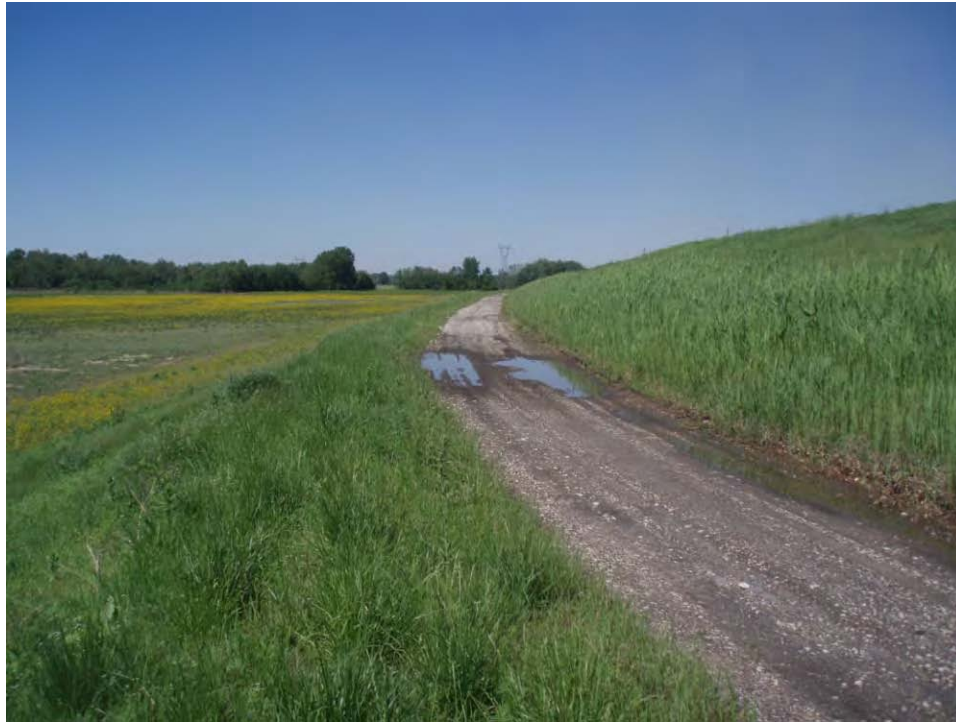
75. Pond B – West embankment bench, looking north. Note inside of bench is wet from recent storm events.

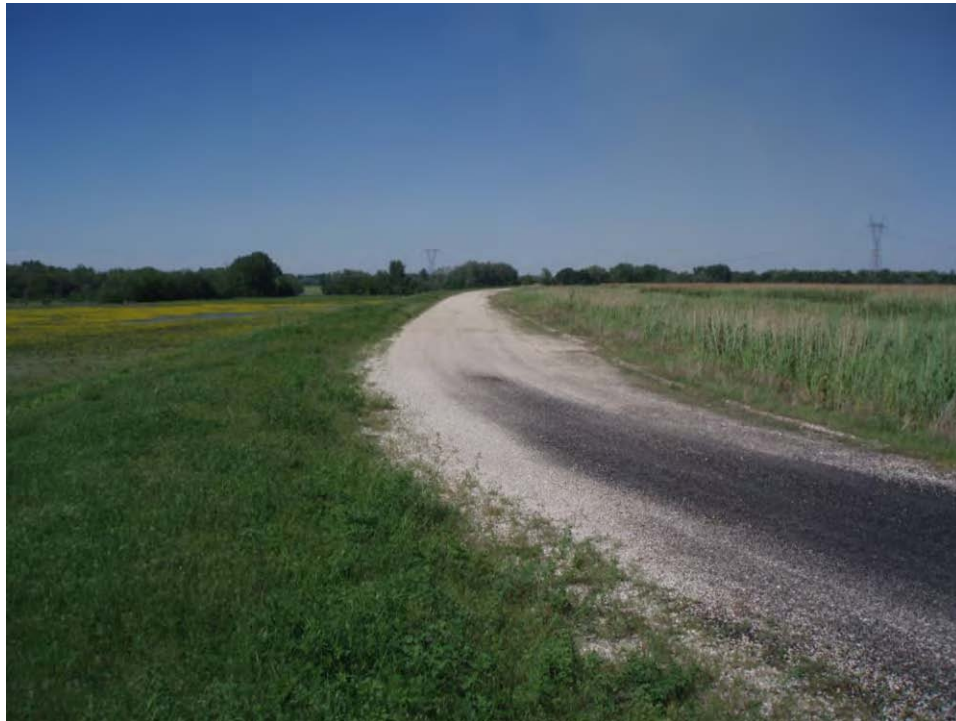
76. Pond B – West embankment crest, looking north.

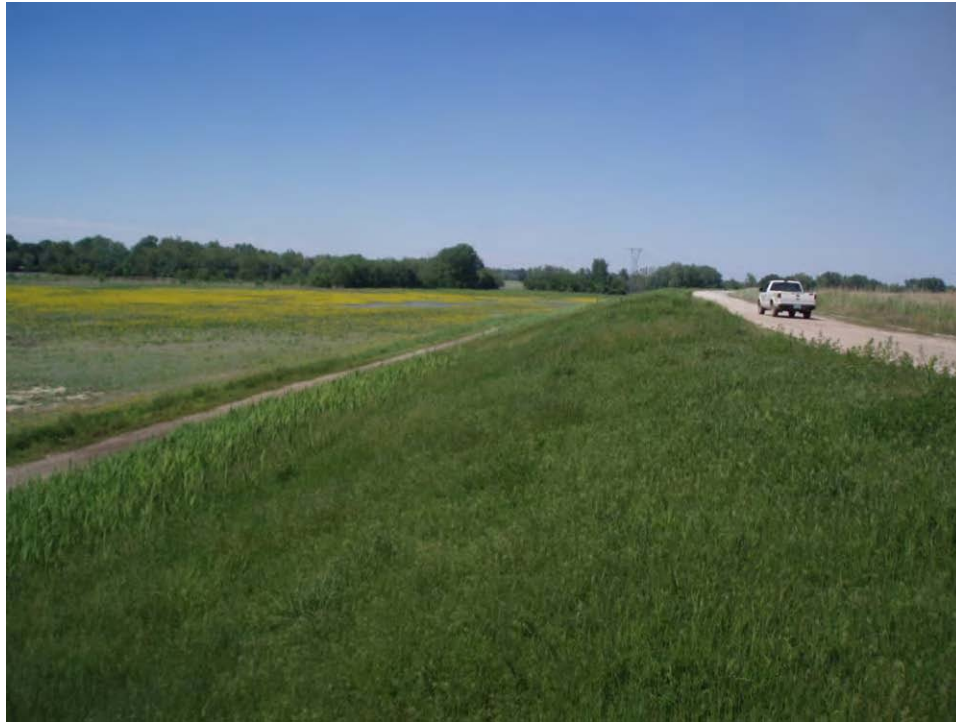
77. Pond B – West embankment upper exterior slope, looking north.

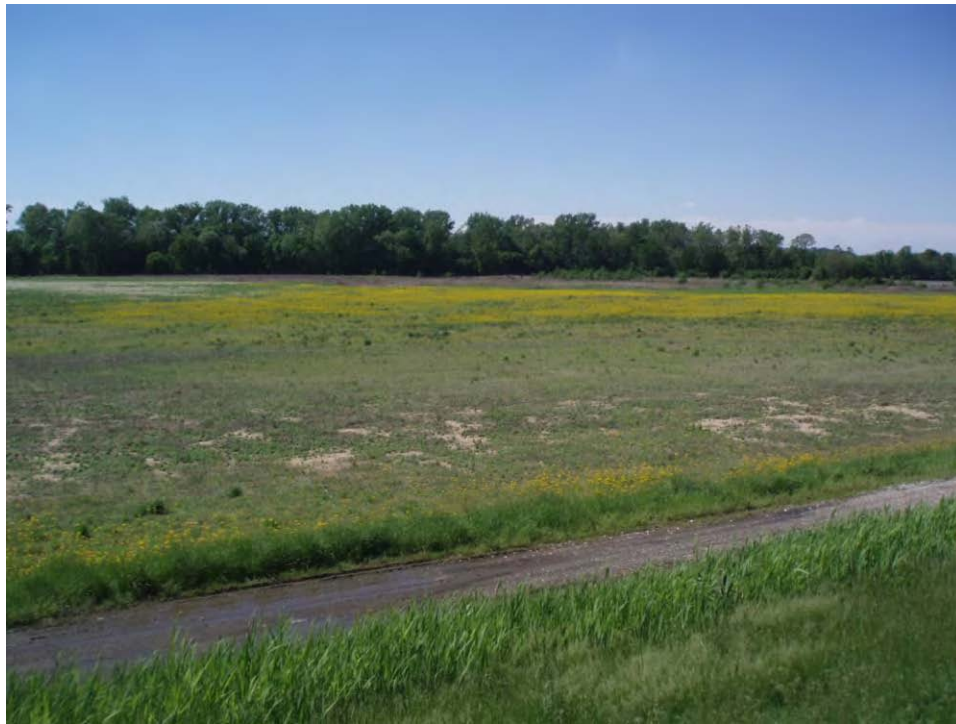
78. Overview of Pond B – West embankment, downstream area, looking west.

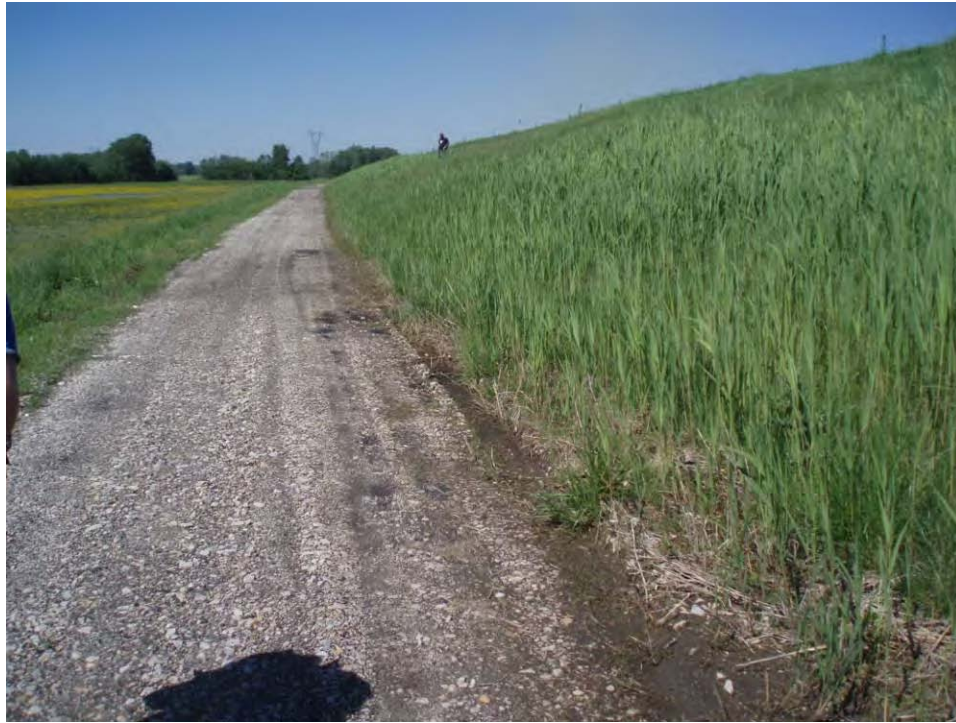
79. Pond B – West embankment bench, looking north at possible seep. Note area is soft and saturated.

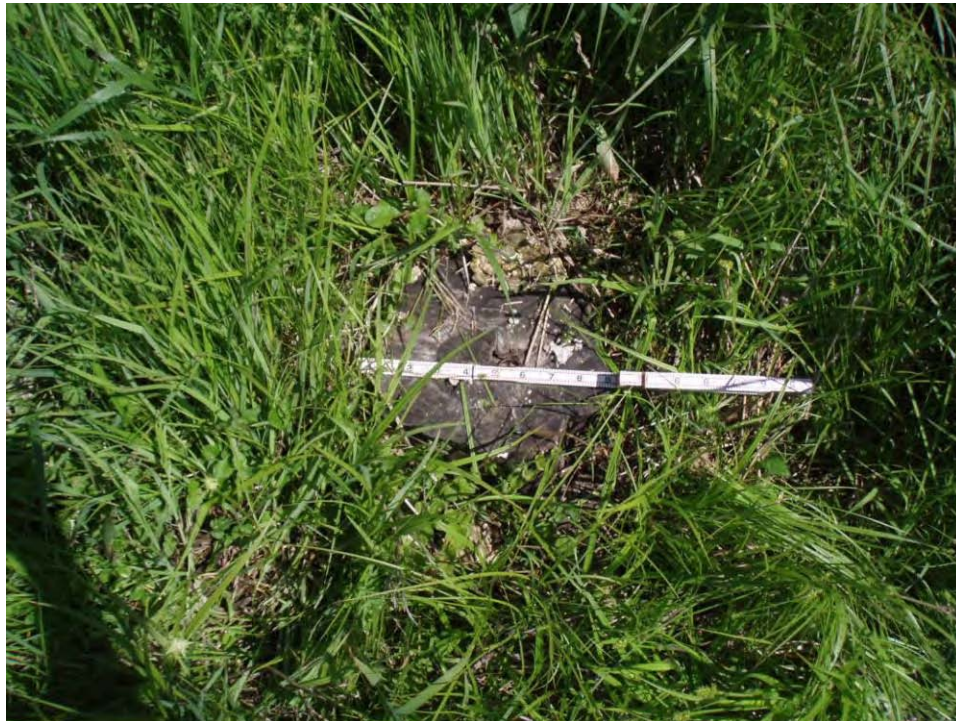
80. Pond B – West embankment lower exterior slope, looking at 0.9-foot-diameter tree stump at toe.

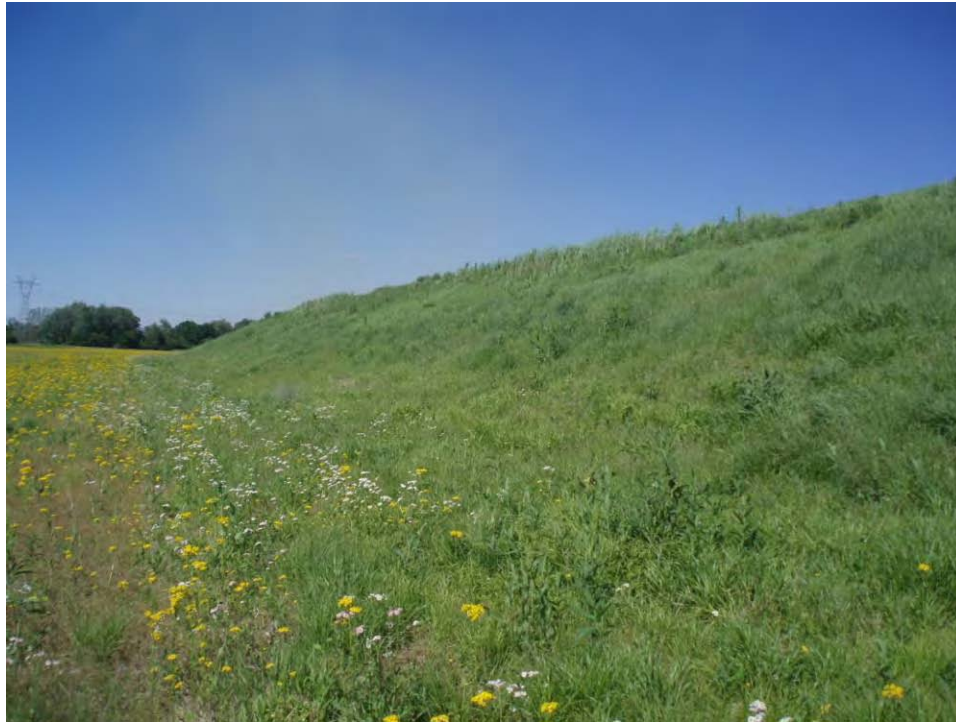
81. Pond B – West embankment lower exterior slope, looking north.

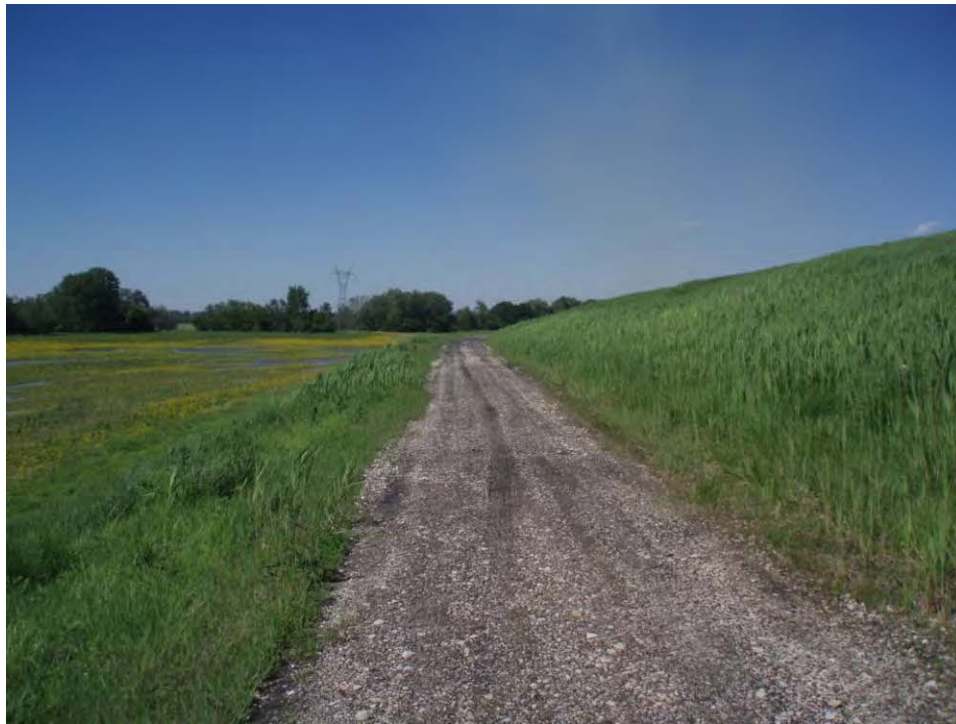
82. Pond B – West embankment bench, looking north.

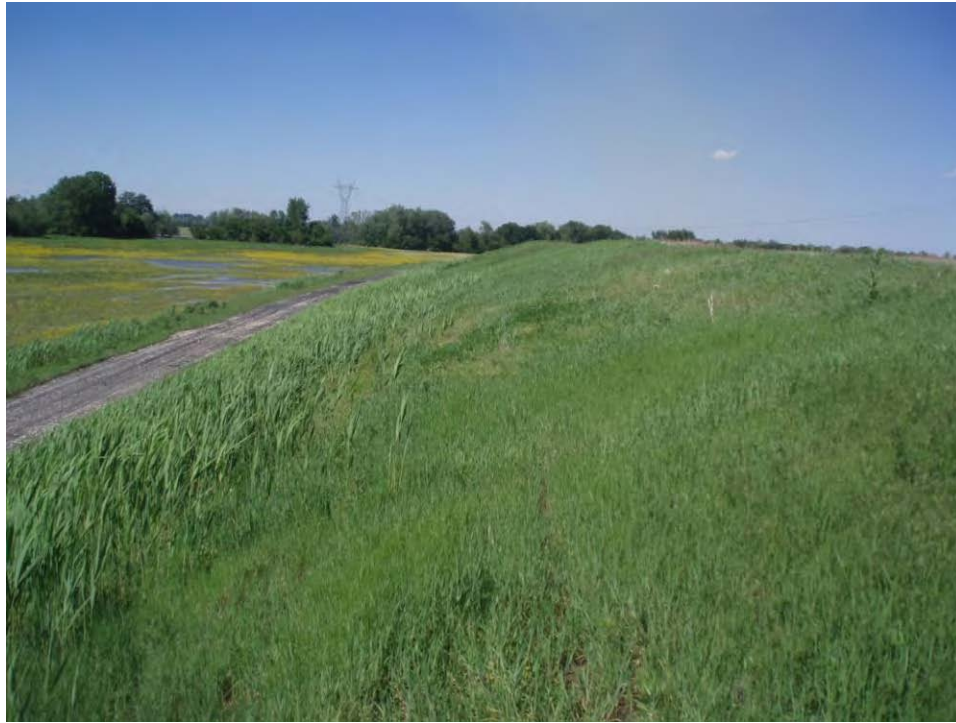
83. Pond B – West embankment upper exterior slope, looking north.

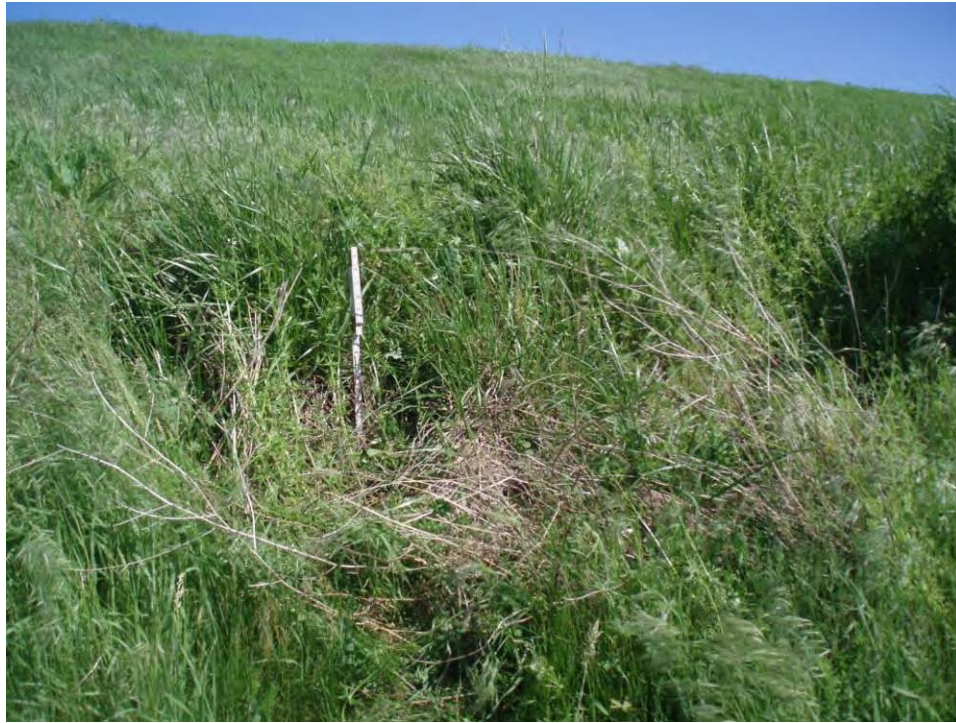
85. Pond B – West embankment lower exterior slope, looking at over-steep area and surficial erosion at bench.

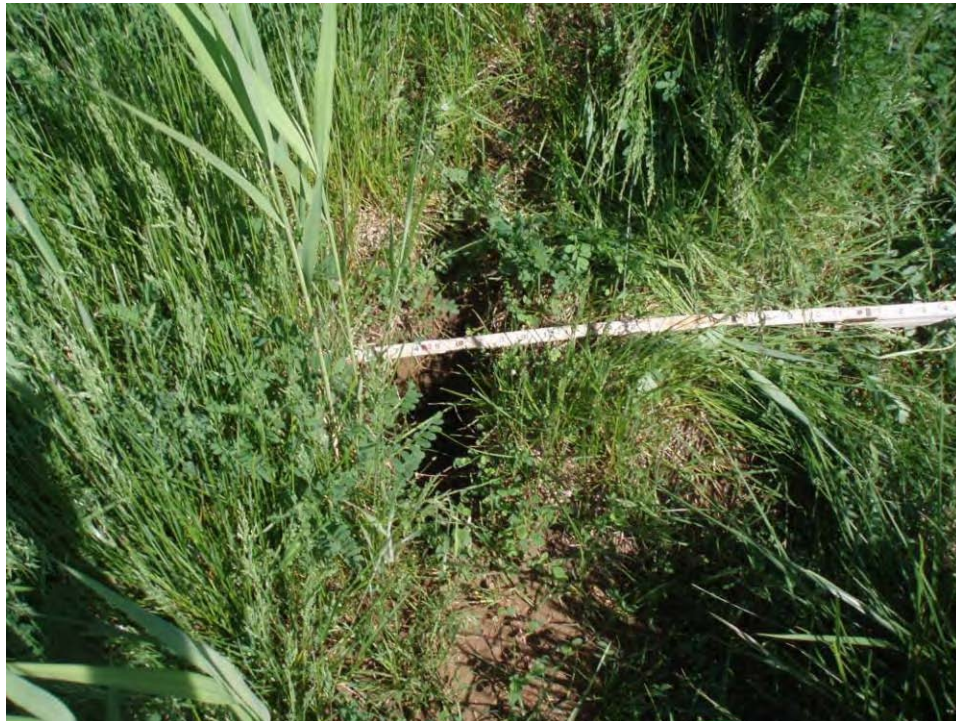
86. Pond B – West embankment upper exterior slope, looking at an 8-inch-diameter rodent hole.

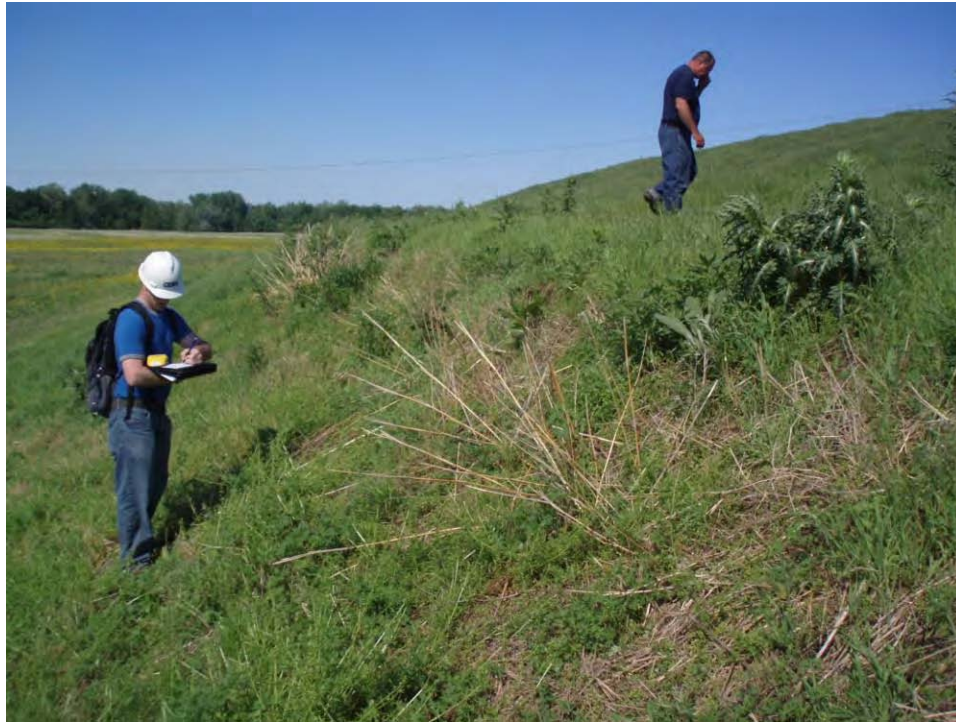
87. Pond B – West embankment lower exterior slope, looking north at over-steep slope and tractor ruts near bench.

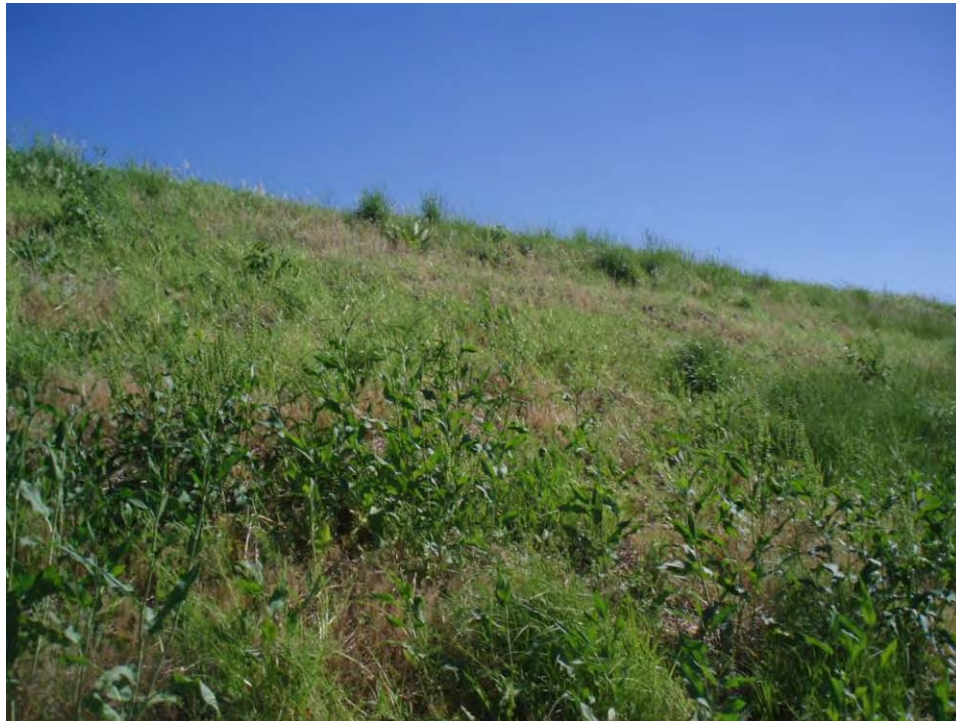
88. Pond B – West embankment lower exterior slope, looking southwest.

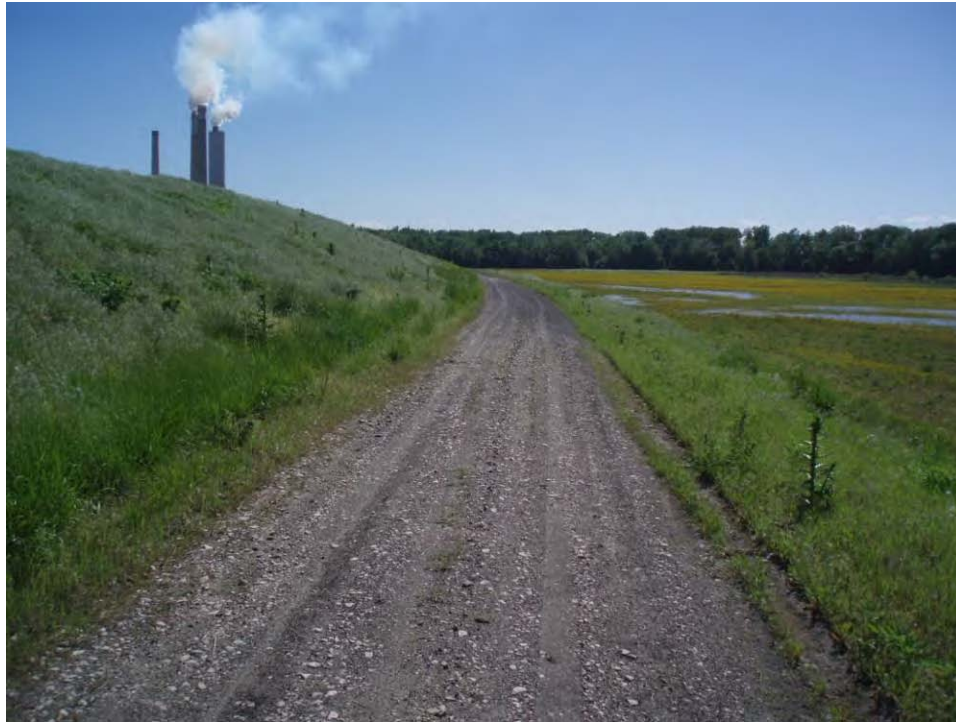
89. Pond B – West embankment bench, looking southwest.

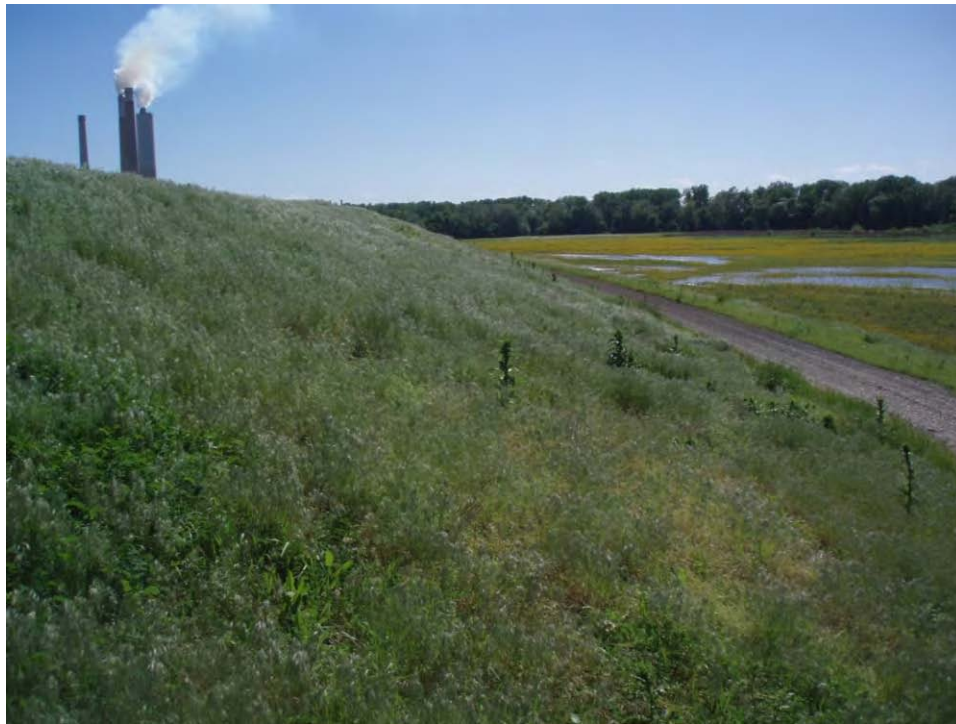
90. Pond B – West embankment upper exterior slope, looking southwest.

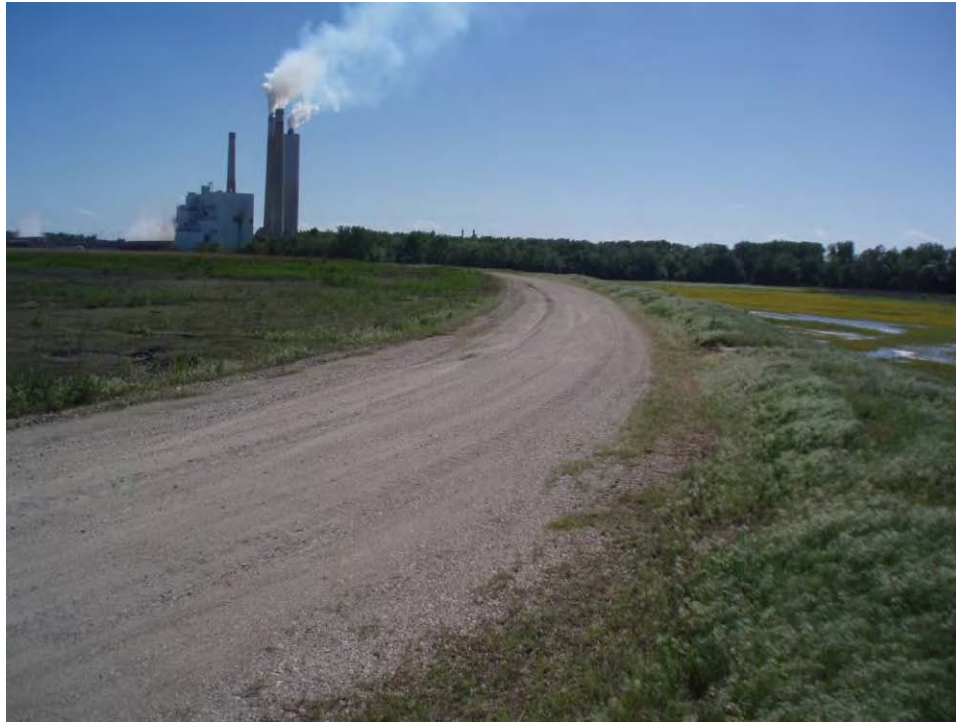
91. Pond B – West embankment crest, looking southwest.

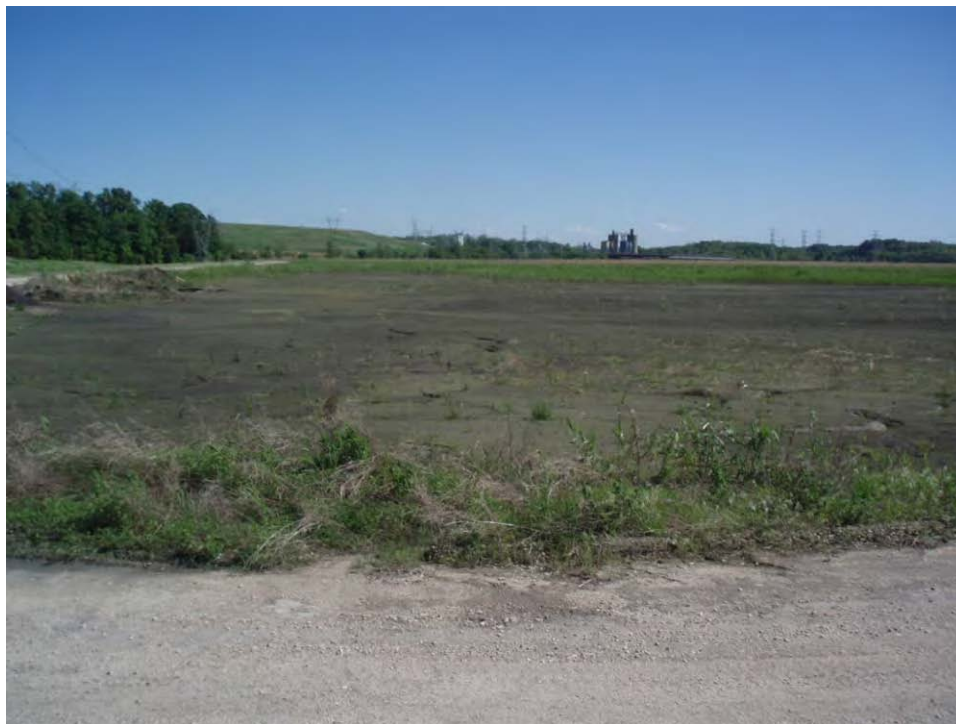
92. Overview of Pond B from northwest corner, looking southeast.

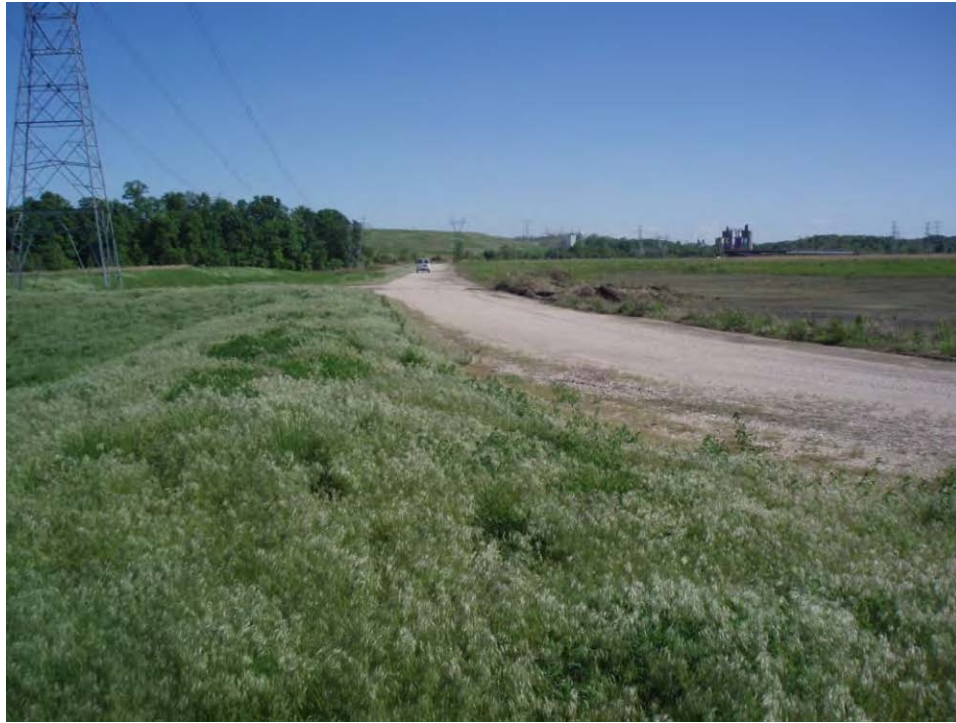
93. Pond B - North embankment crest, looking southeast.

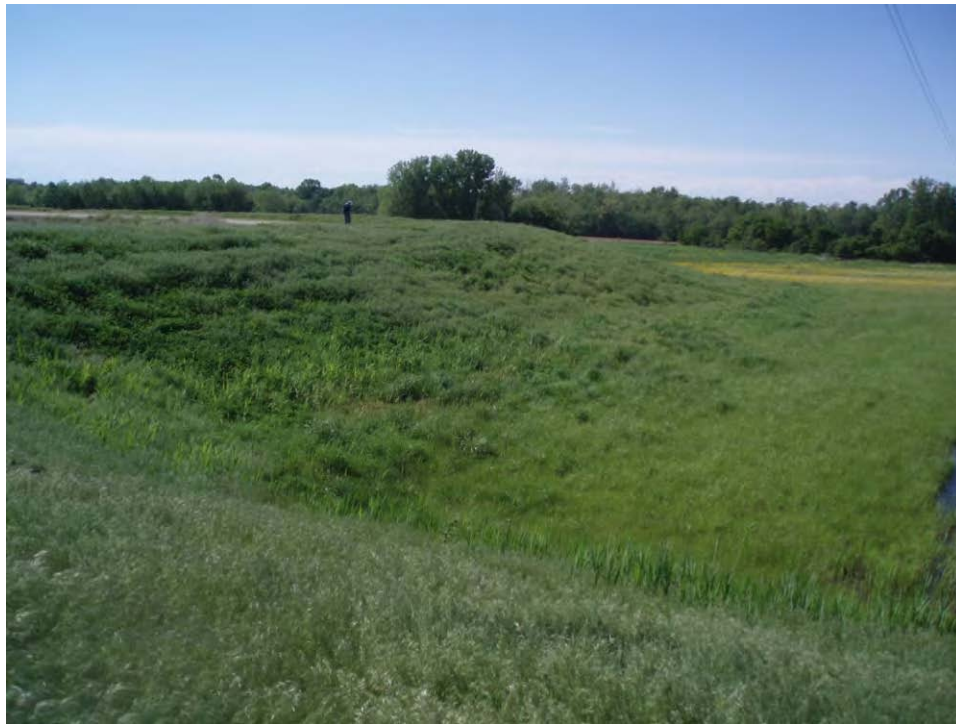
94. Pond B - North embankment exterior slope, looking northwest.

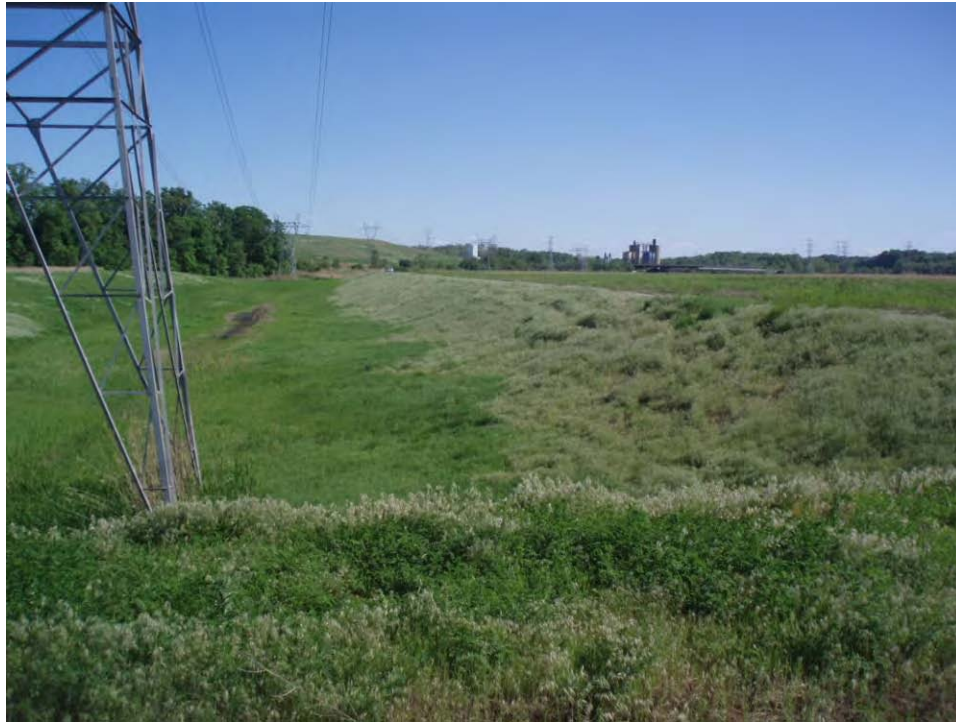
95. Pond B – North embankment exterior slope, looking southeast.

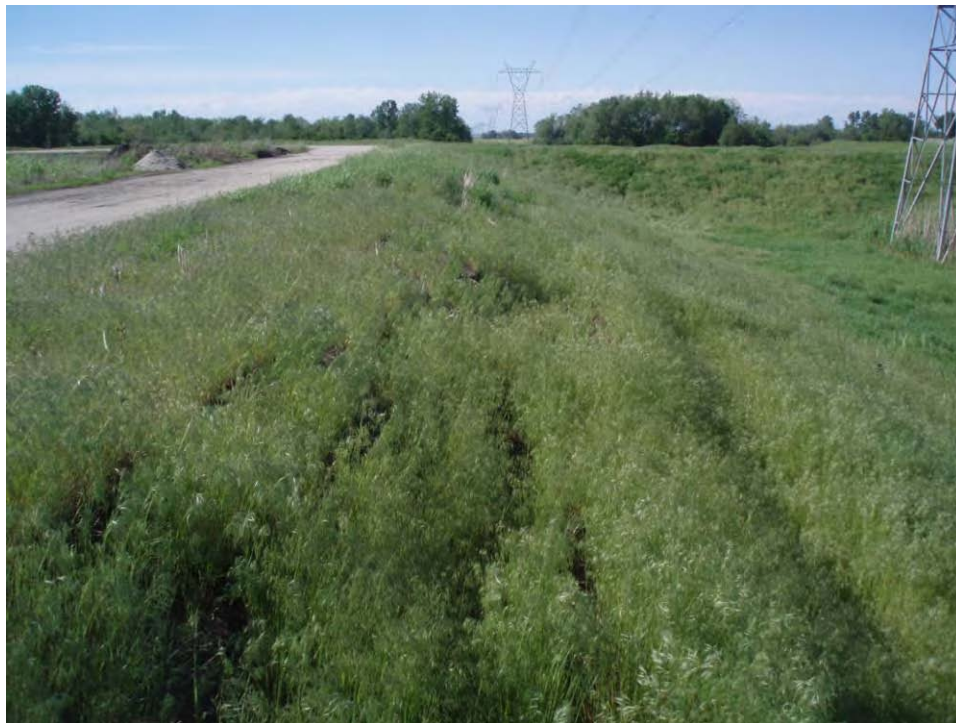
96. Pond B – North embankment exterior slope looking northwest at tractor ruts, bare spots, very soft stabilized FGD.

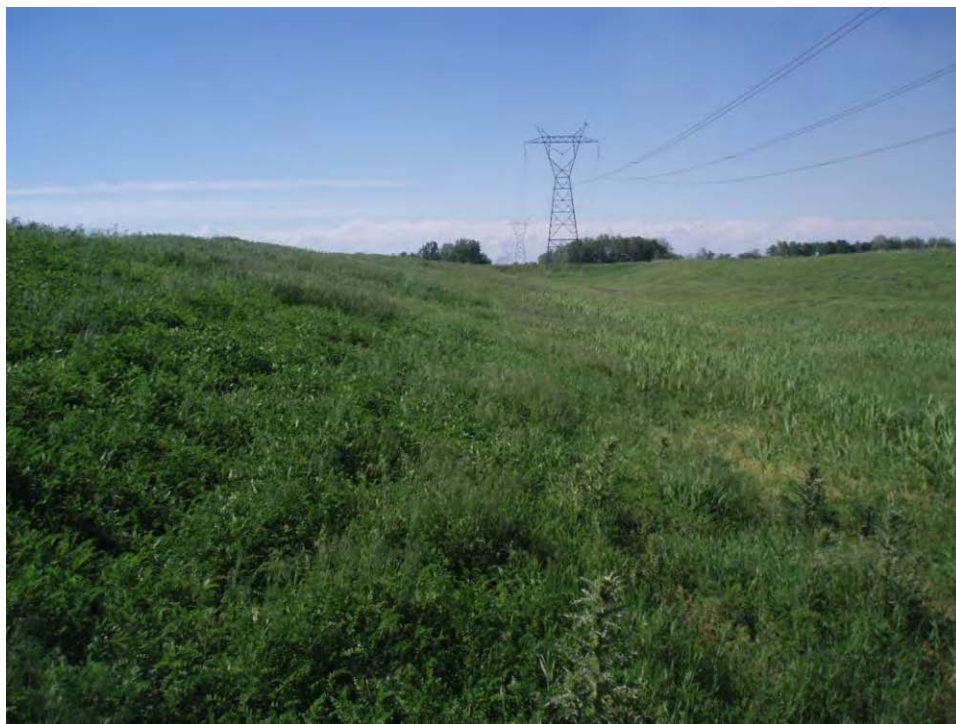
97. Pond B – North embankment exterior slope, looking northwest.

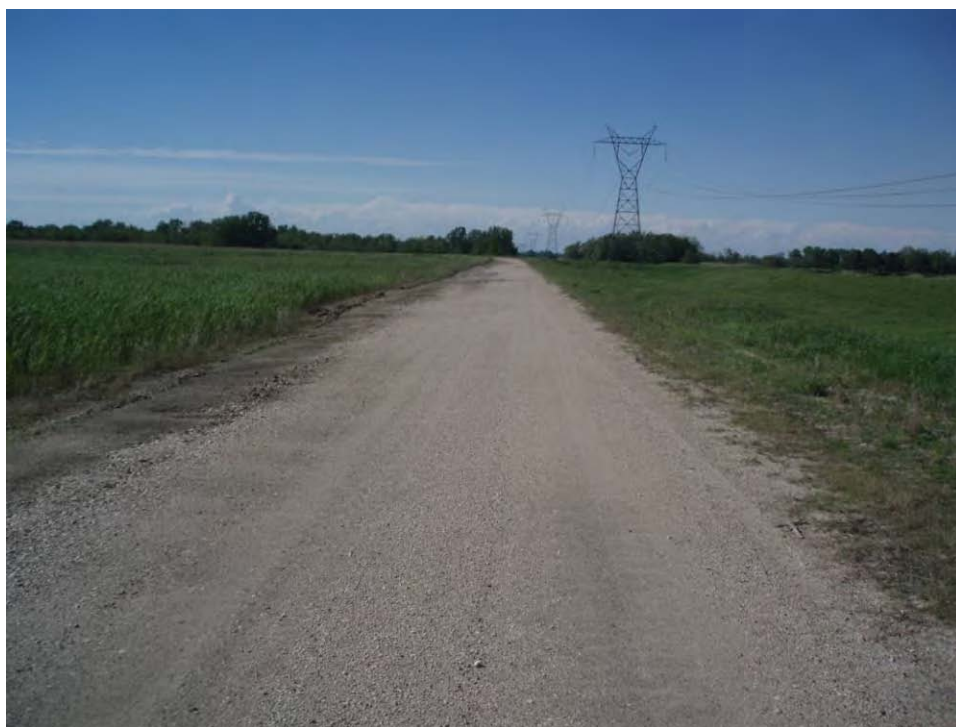
98. Pond B – North embankment crest, looking northwest.

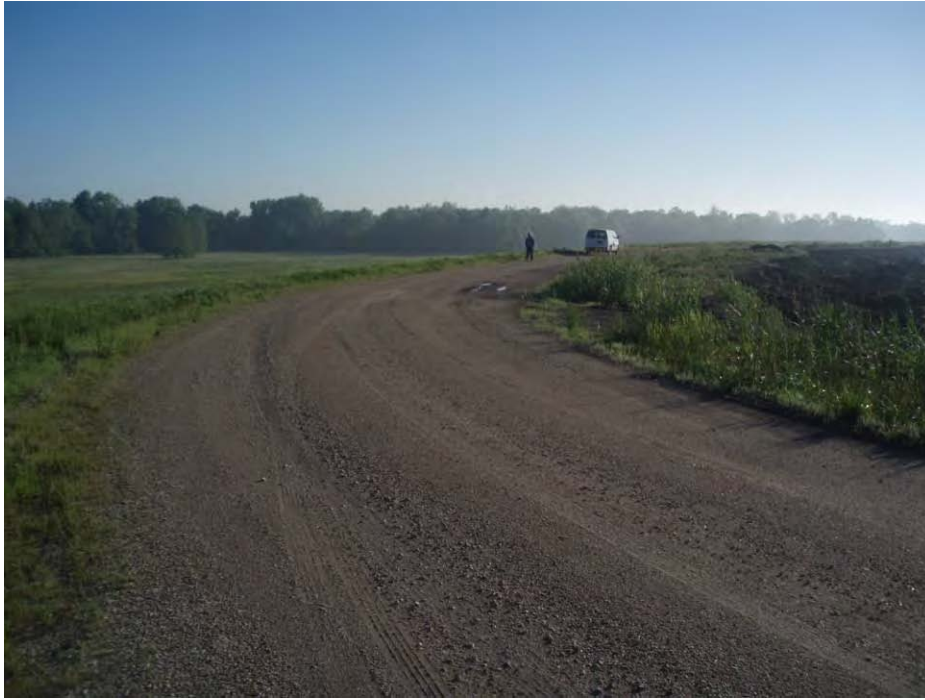
99. Pond C – West embankment crest, looking northeast.

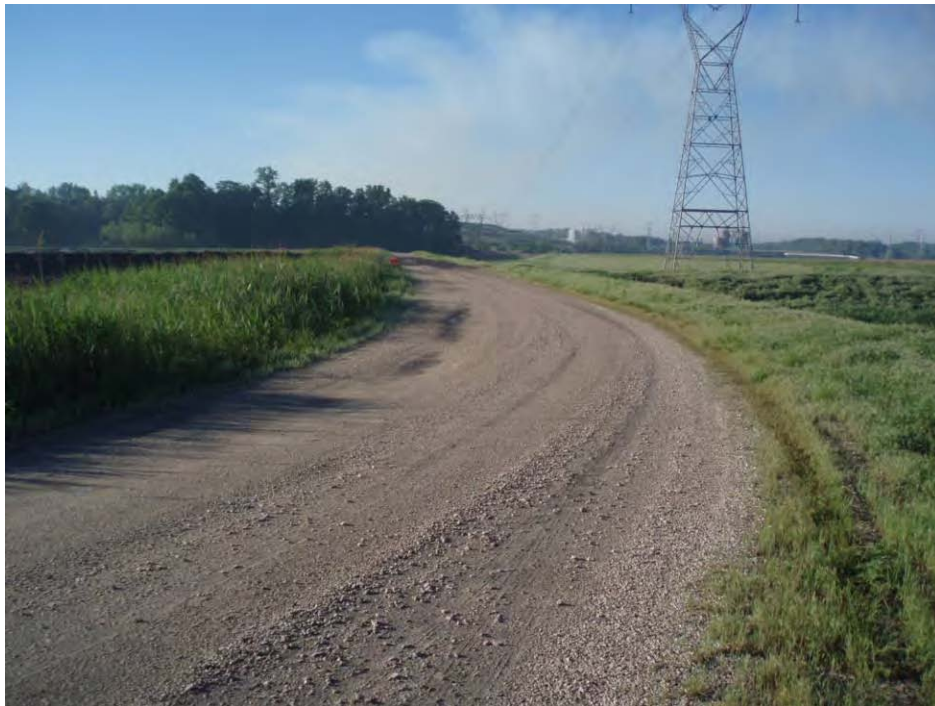
100. Pond C – South embankment crest, looking southeast.

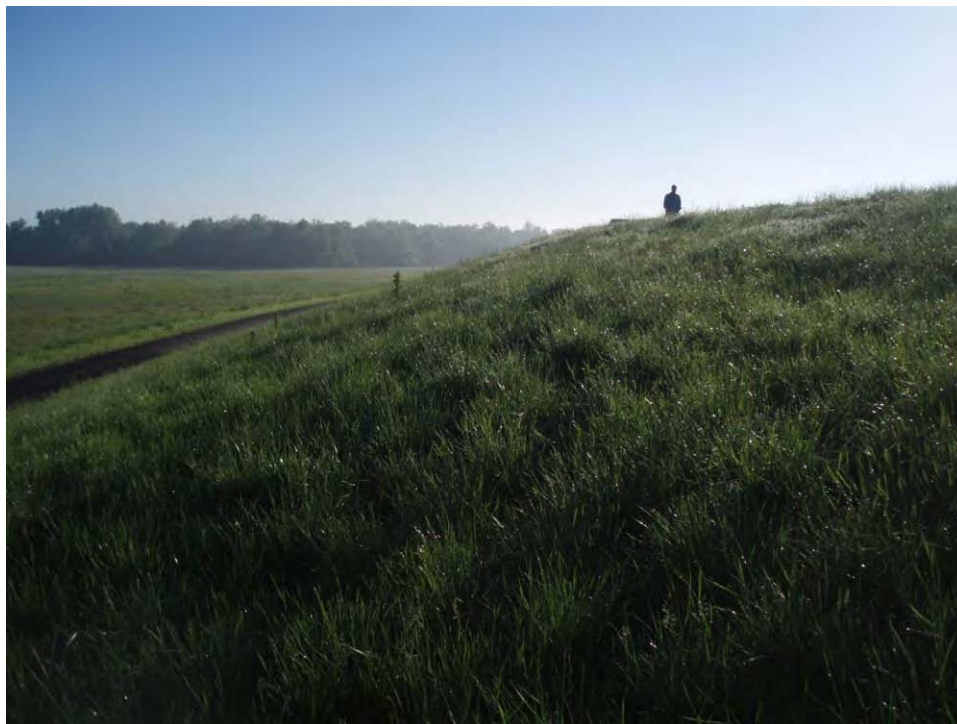
101. Pond C – West embankment upper exterior slope, looking northeast.

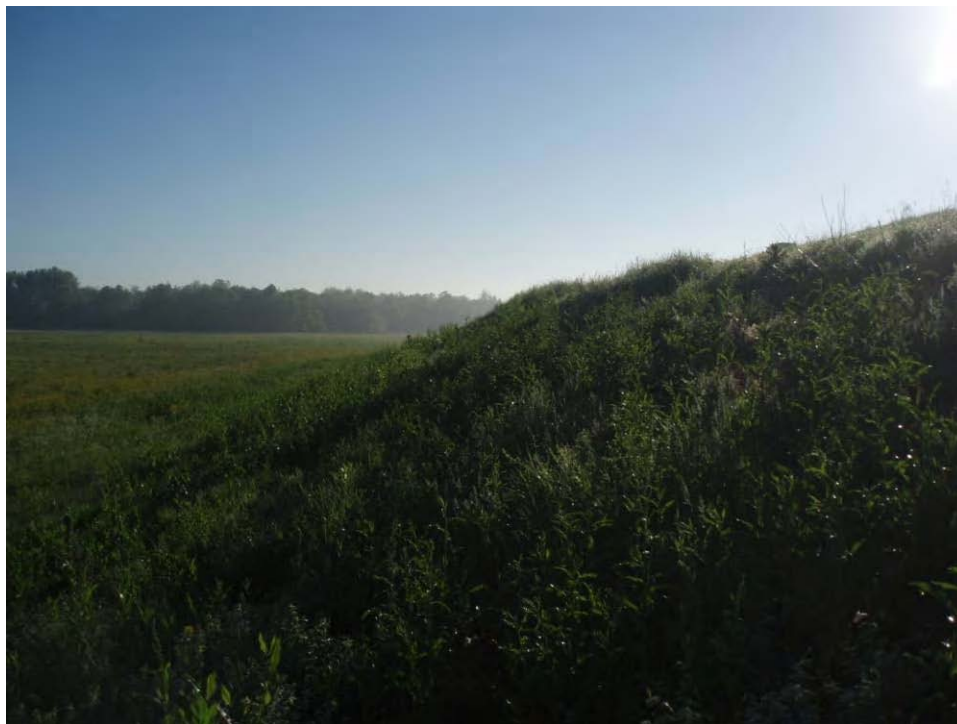
103. Pond C - West embankment lower exterior slope, looking northeast.
